Project No. CA0053301.4756

**FINAL PROPERTY CONDITION ASSESSMENT**  
**CHESTERMERE REGIONAL RECREATION CENTRE**  
**201 W CHESTERMERE DR**  
**Chestermere, Alberta**

AUGUST 28, 2025

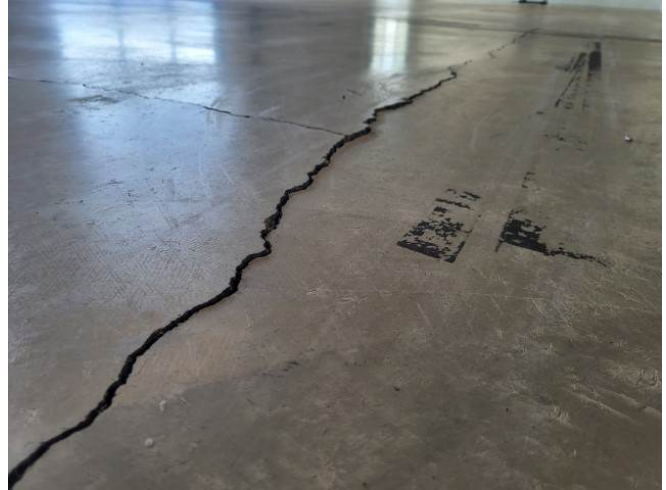
The floor slab on the second floor on the undeveloped area had several cracks and displacement. Area of cracking were also observed on the 2nd floor slab of the boxing gym. According to the Operations Manager the slabs have been reviewed by a structural engineer and are currently being monitored for further movement. No engineering report was available for review. We recommend following up with the recommendation of the structural review. We have included a project for the repairs; however, it will vary based on the structural review study findings. During our follow-up site visit dated August 15, 2025, we were informed that the permit request is in progress.

Cracking and Displacement in the 2nd Floor Slab of Undeveloped Area

#### 1.1.1 Repair Cracking in Suspended Slab

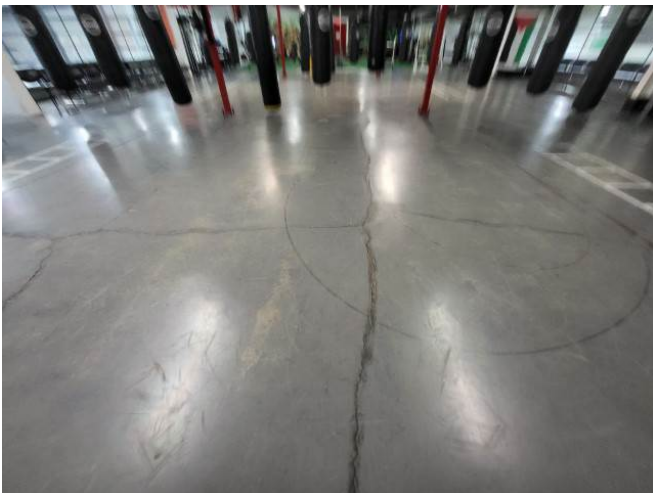
Cracking in the 2nd Floor Boxing Gym Slab

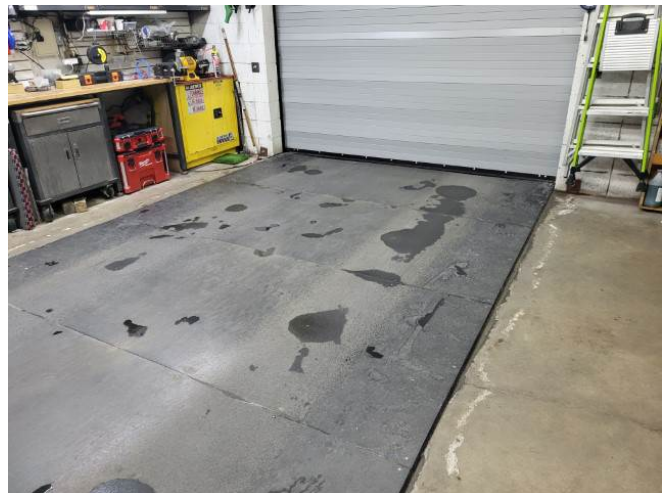
The concrete slab-on-grade in the Zamboni garage was observed to be deteriorated from the wheels of the equipment. Rubber panels were installed on some of the affected areas; however, repairs are required. The base of the canopy columns and the columns supports were noted to have rust and spalling concrete. A repair project is included for the repairs to the concrete slab-on-grade surface in the Zamboni garage and canopy columns.

Zamboni Slab on Grade Covered with Rubber Panels (Small)

#### 1.1.2 Repair Zamboni Garage and Canopy Columns

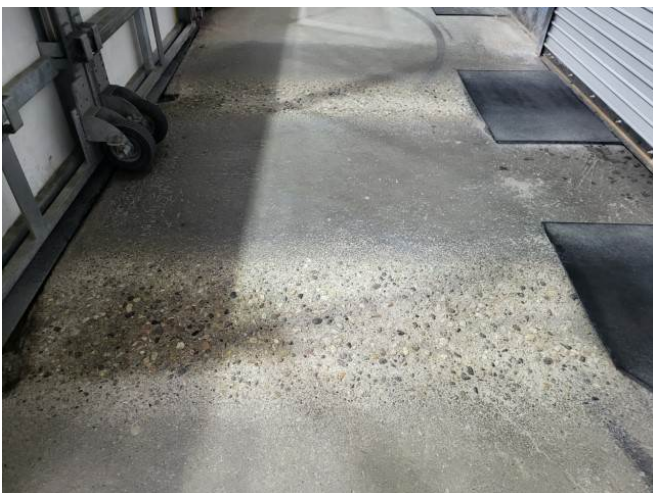
Deteriorated Slab on Grade in Zamboni Garage (Small)

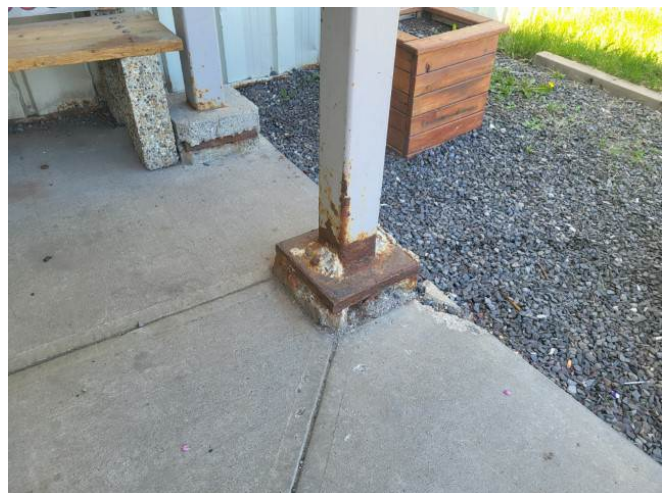
Corroded and Deteriorated Base of the Canopy Columns and the Columns Supports

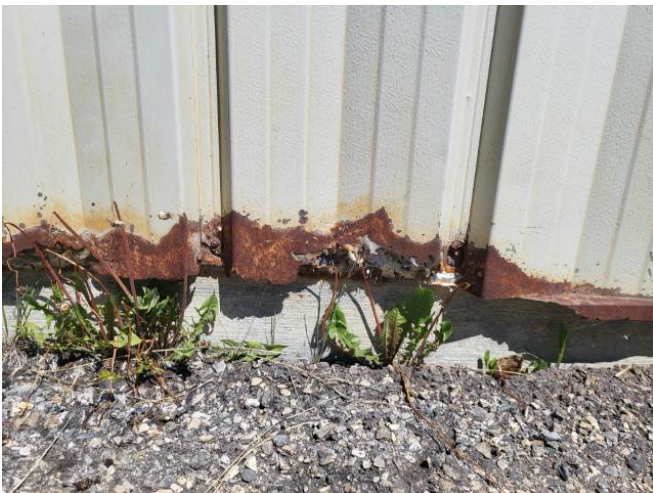
Corroded Metal Panel Cladding - South Elevation

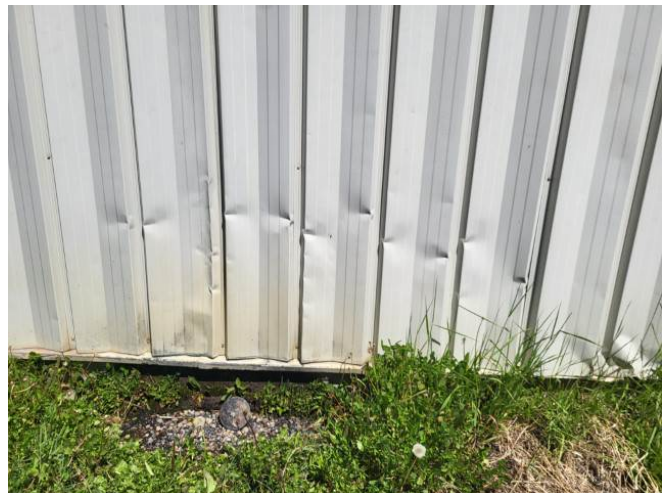
Dented Cladding - South Elevation

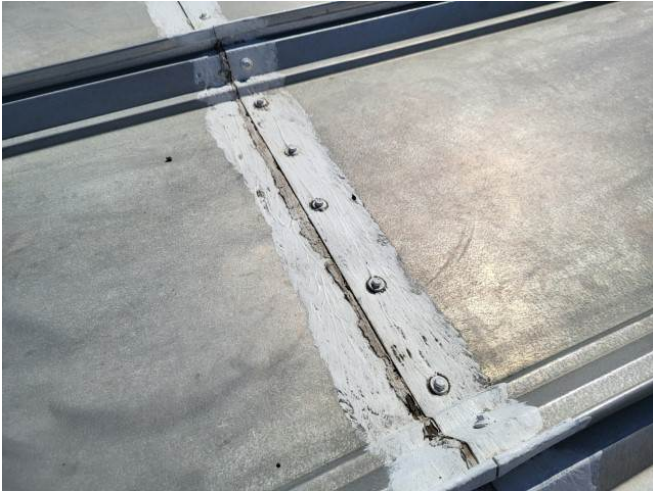
Deteriorated Roof Repairs - Fasteners

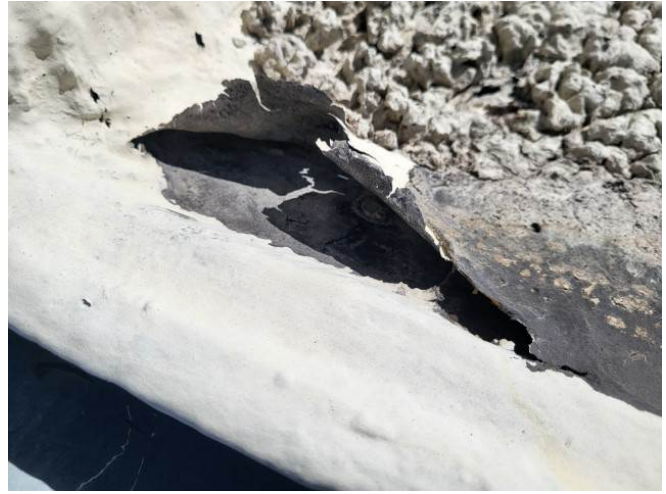
Debonded Roof Repairs

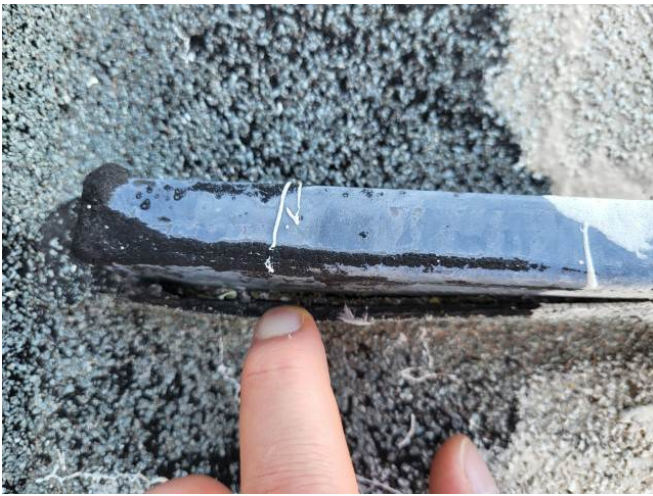
Debonded Roof Repairs Near Ribs

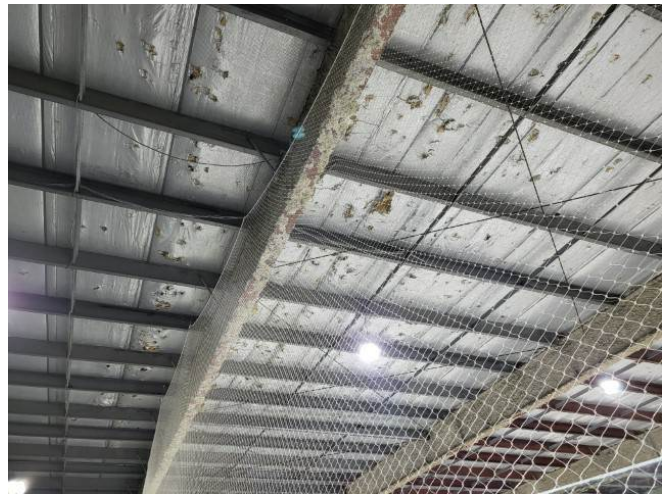
Damaged Roofing Backpacked Insulation - Red Arena

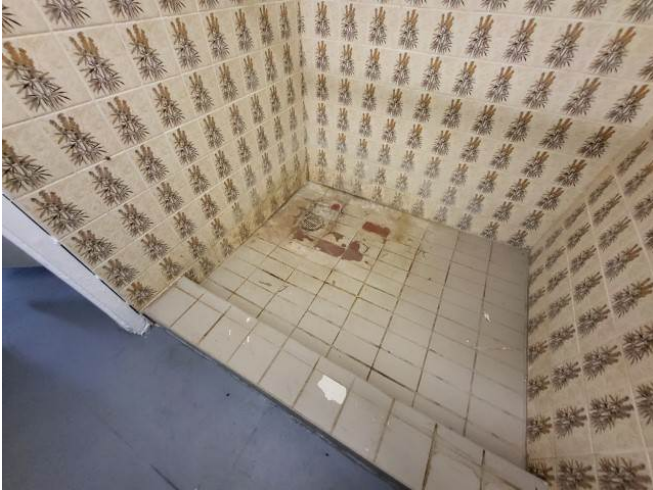
Cracked and Damaged Ceramic Tiles

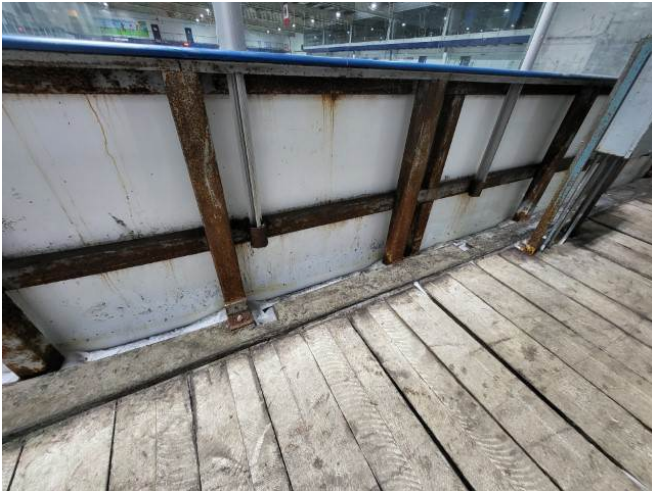
Corrosion on Dashboards - Blue Arena

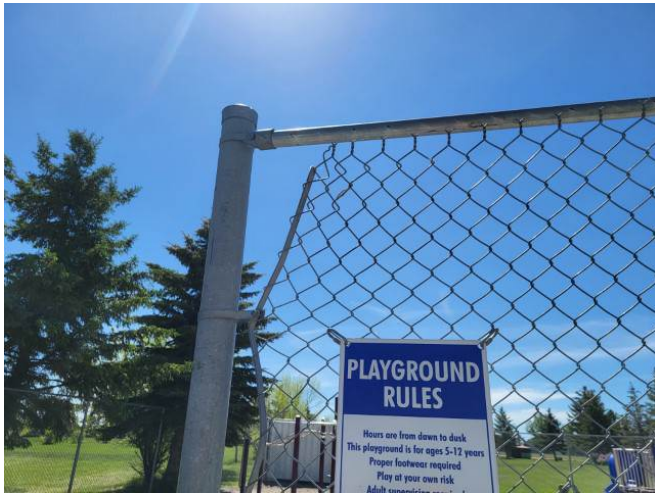
Damaged Chain Link Fencing - West

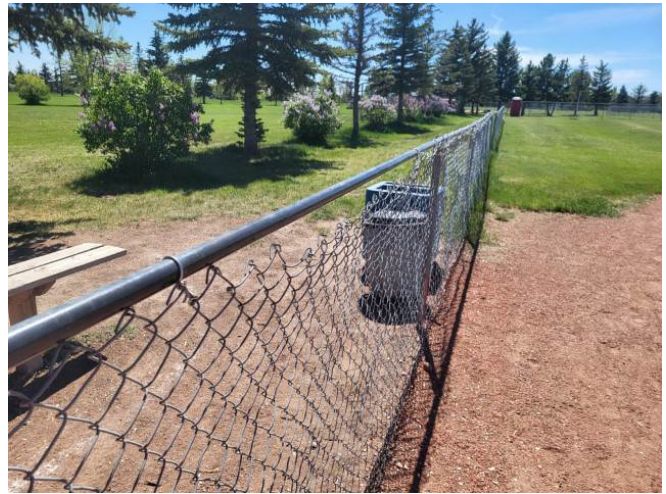
Damaged Chain Link Fencing - North

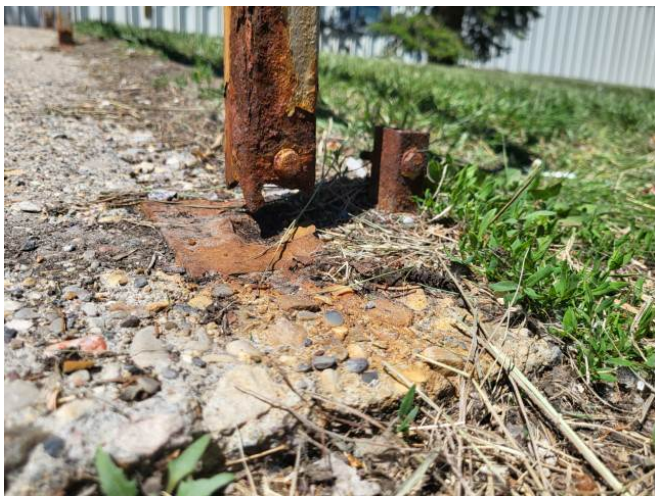
Corroded Railing - Entrance

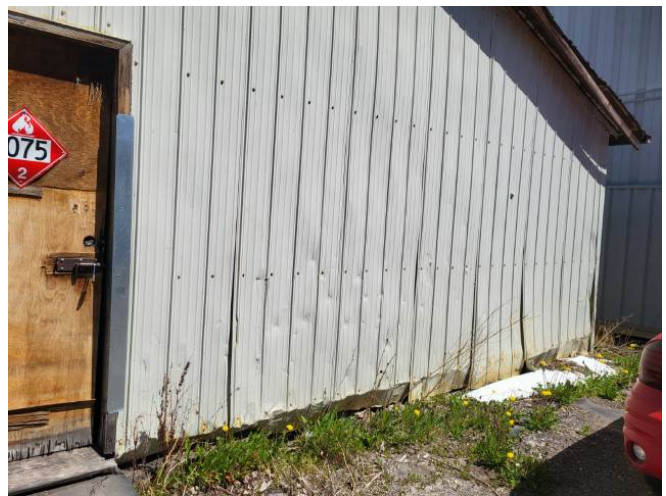
Storage Shed - Damaged Wall Metal Cladding

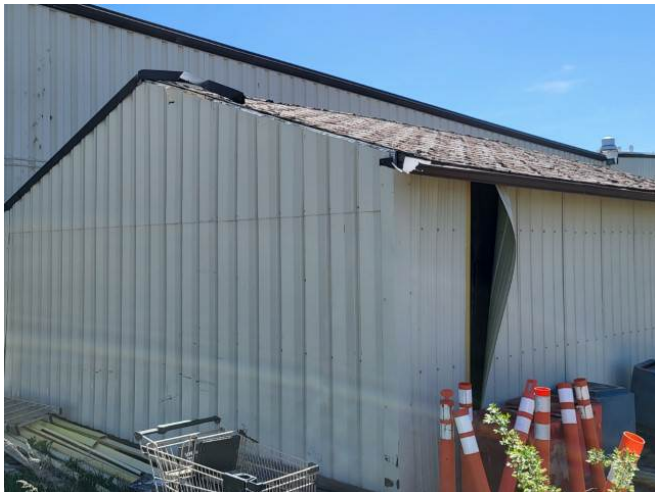
Storage Shed - Dislodged Wall Metal Cladding

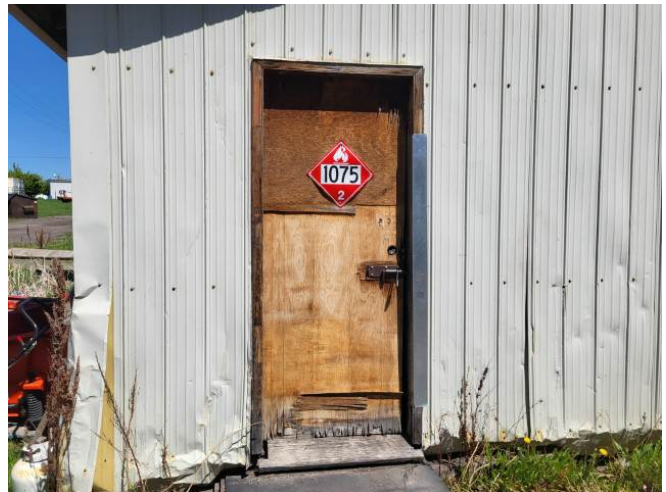
Storage Shed - Deteriorated Man Door

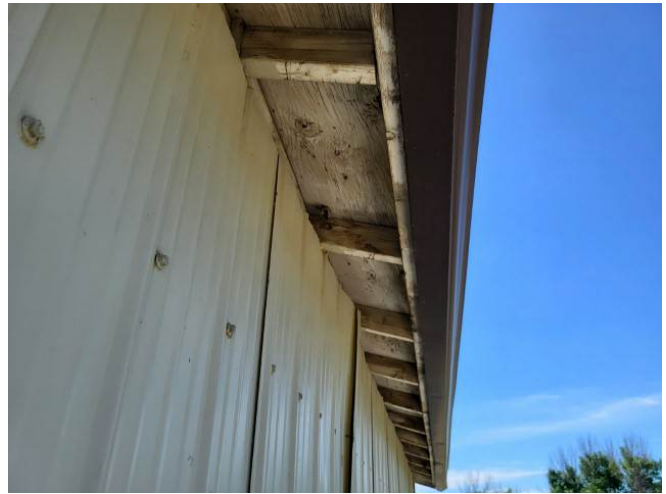
Storage Shed - Missing Overhangs Soffit

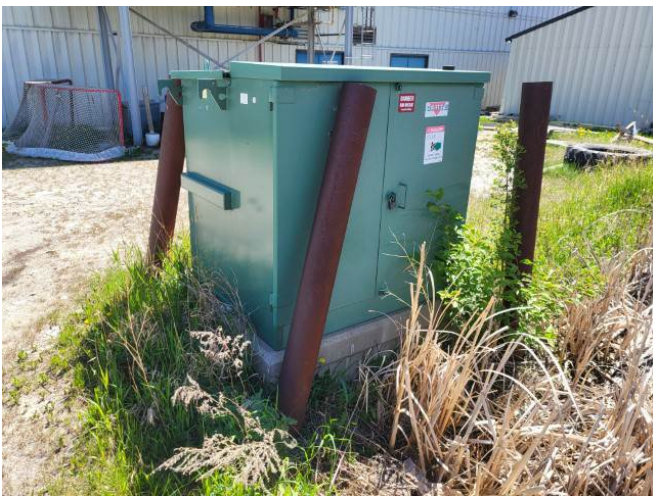
- Tilted metal bollards were observed around the transformer.
- The ceiling fan in the Auditorium kitchen was covered in dust and dirt.
- The BFP was last inspected by Sprouse in April, 2024 and overdue for inspection.

Pad Mounted Transformer - Tilted Bollards

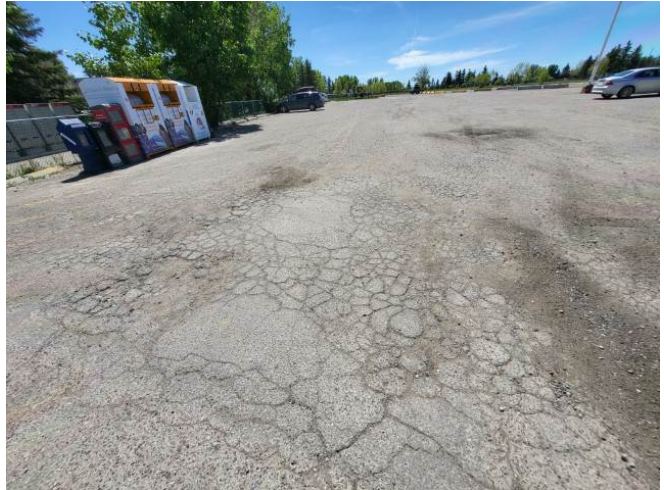
Deteriorated Parking Lot Asphalt Pavement

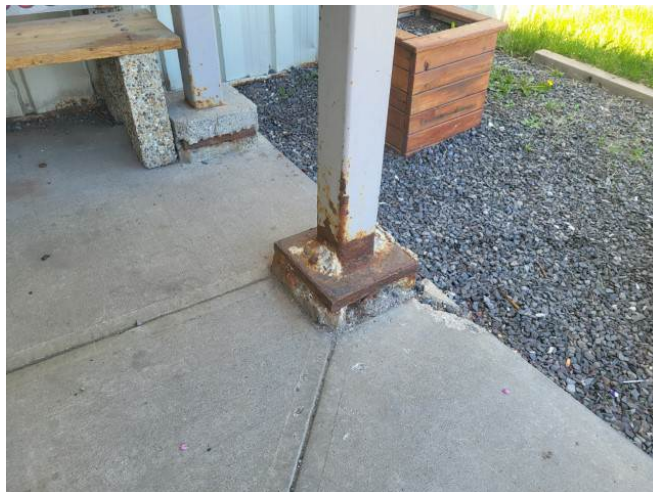
Photo #9: Corroded and Deteriorated Base of the Canopy Columns and the Columns Supports

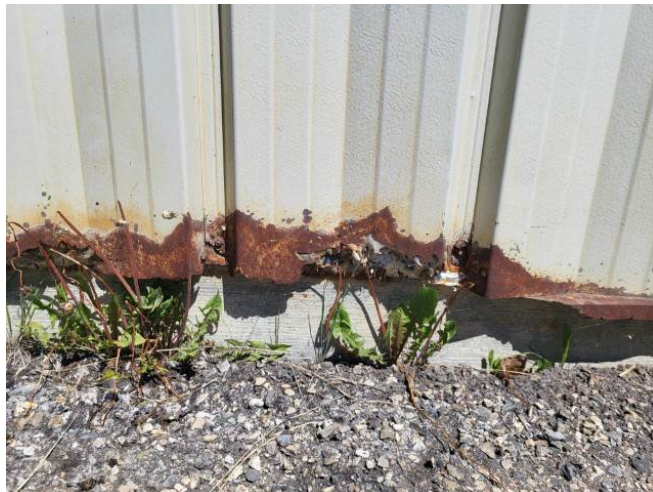
Photo #15: Corroded Metal Panel Cladding - South Elevation

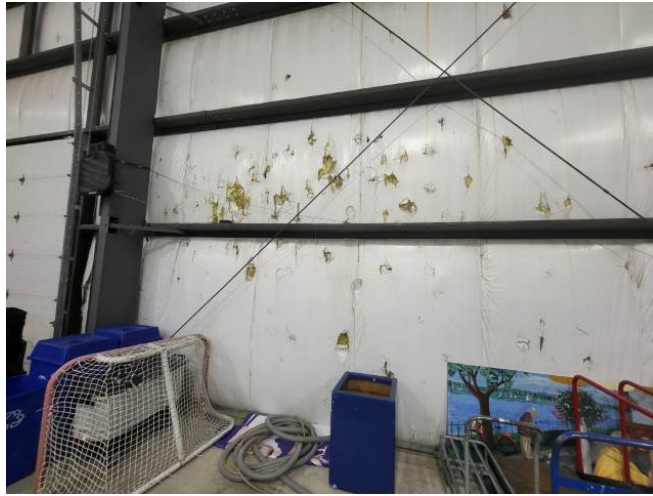
Photo #16: Damaged Insulation and Vapour Retarder on the Interior Face of Red Arena Walls

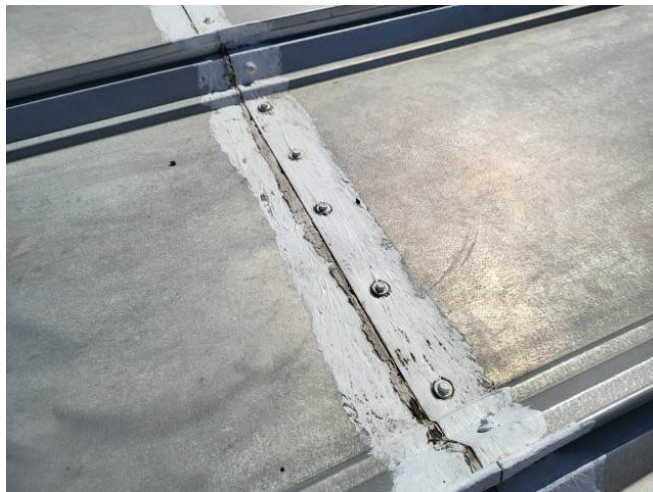
Photo #26: Deteriorated Roof Repairs - Fasteners

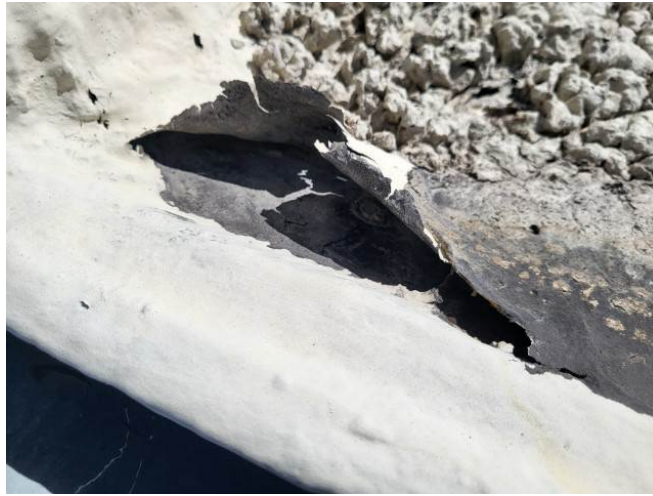
Photo #27: Debonded Roof Repairs

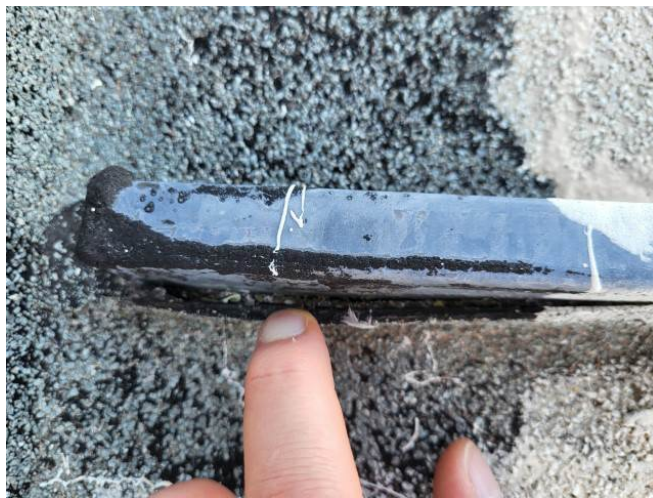
Photo #28: Debonded Roof Repairs Near Ribs

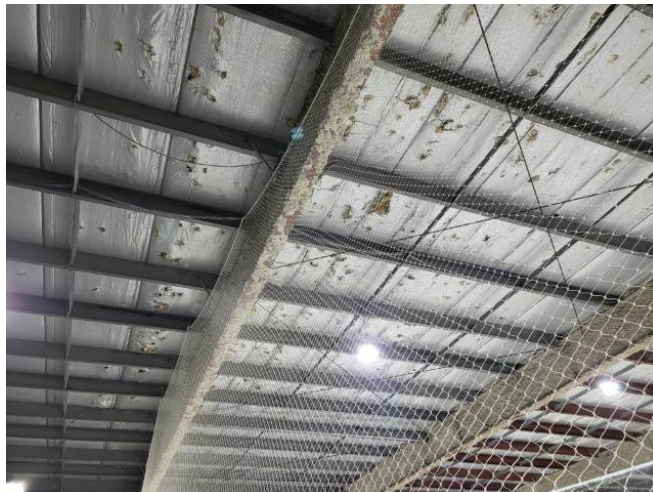
Photo #29: Damaged Roofing Backpacked Insulation - Red Arena

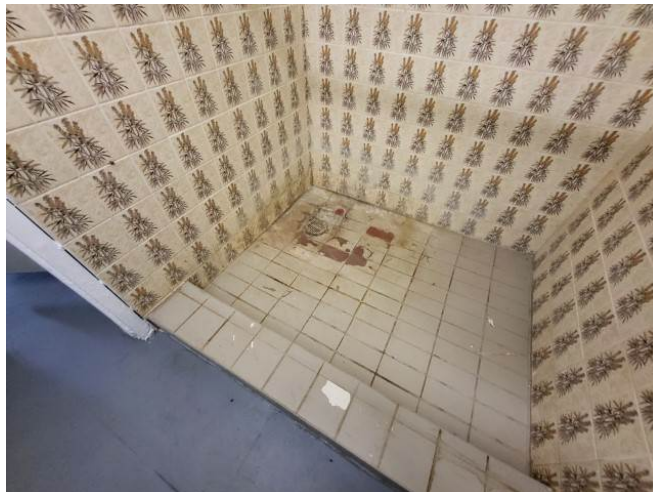
Photo #41: Cracked and Damaged Ceramic Tiles

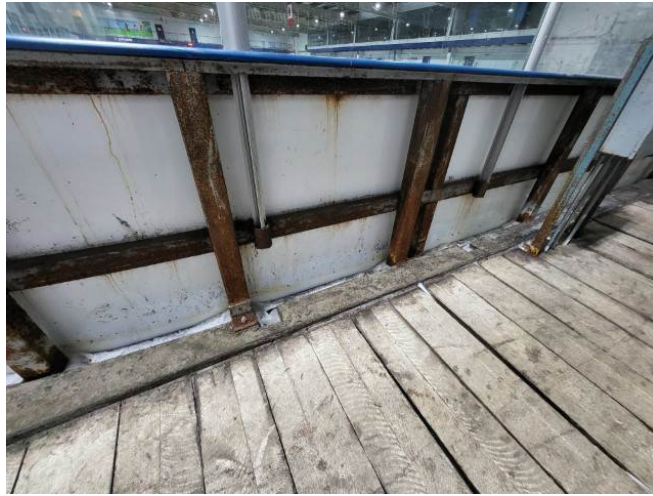
Photo #42: Corrosion on Dashboards - Blue Arena

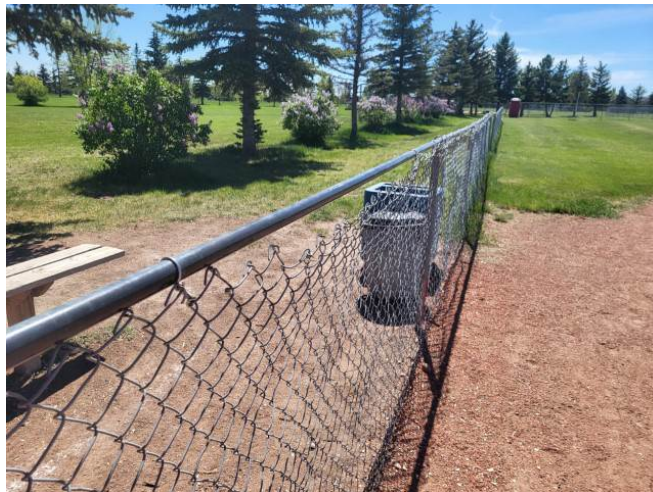
Photo #44: Damaged Chain Link Fencing - North

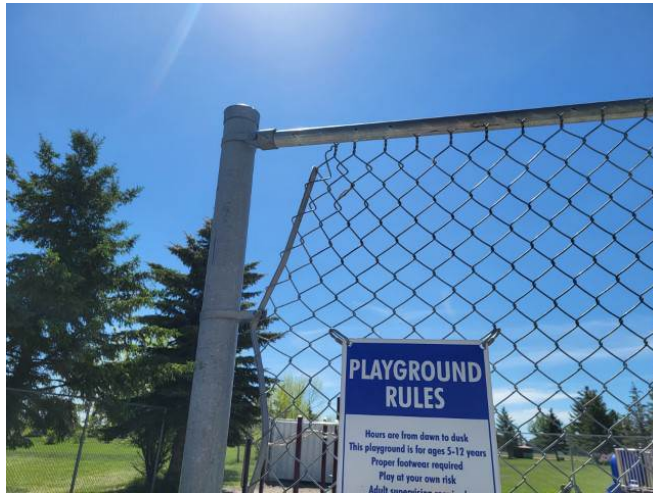
Photo #45: Damaged Chain Link Fencing - West

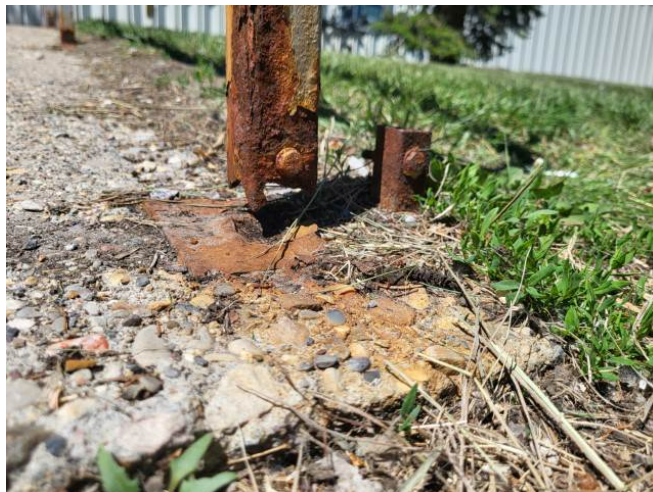
Photo #47: Corroded Railing - Entrance

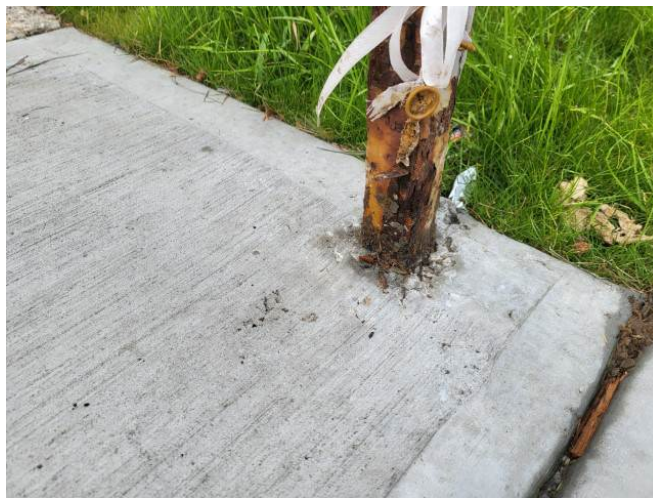
Photo #49: Aug 15\_ Railing Imbedded in Concrete\_ Corrossion Present

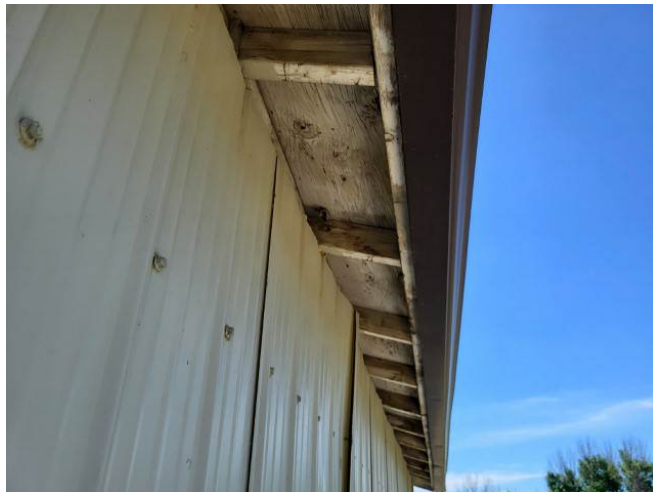
Photo #53: Storage Shed - Missing Overhangs Soffit

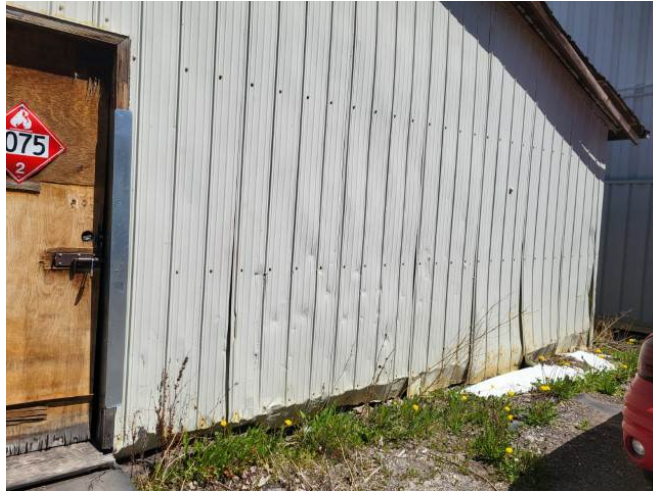
Photo #54: Storage Shed - Damaged Wall Metal Cladding

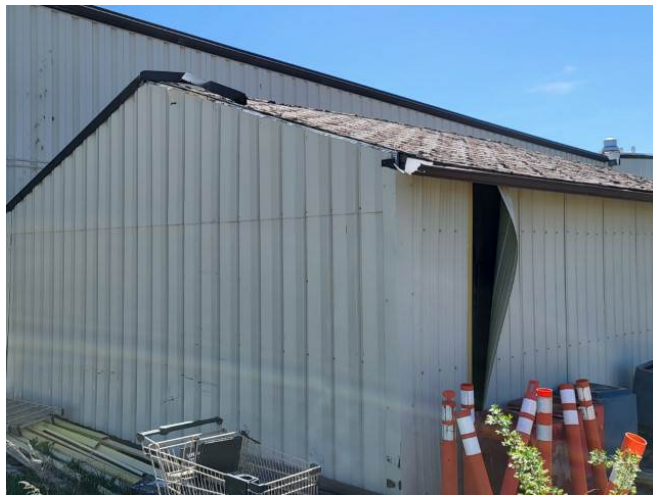
Photo #55: Storage Shed - Dislodged Wall Metal Cladding

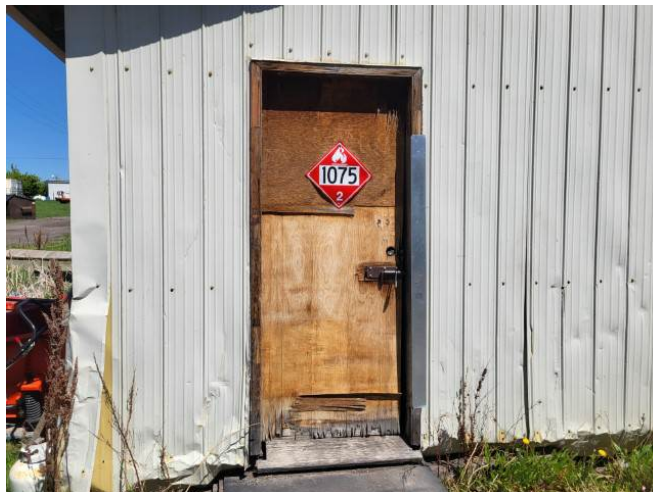
Photo #56: Storage Shed - Deteriorated Man Door

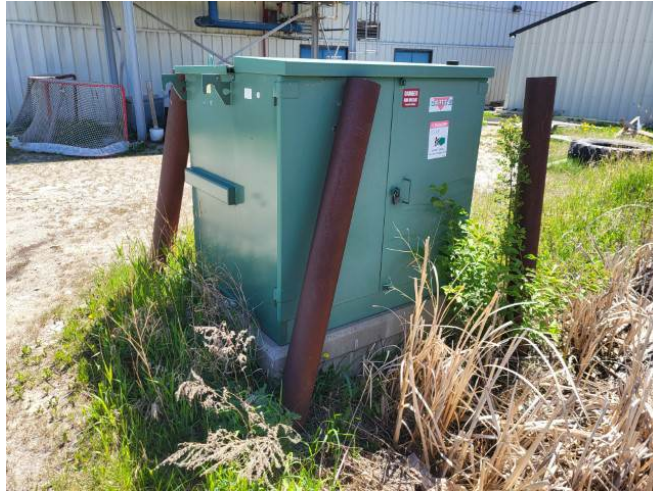
Photo #57: Pad Mounted Transformer - Tilted Bollards

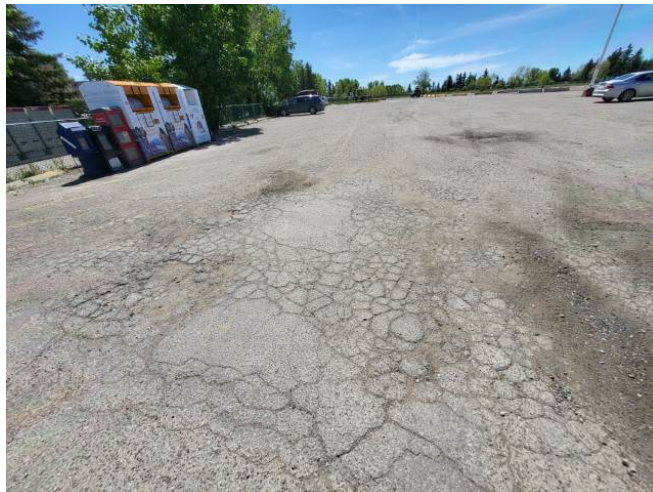
Photo #59: Deteriorated Parking Lot Asphalt Pavement
