Project No. CA0053301.4756

**FINAL PROPERTY CONDITION ASSESSMENT**  
**CHESTERMERE REGIONAL RECREATION CENTRE**  
**201 W CHESTERMERE DR**  
**Chestermere, Alberta**

AUGUST 28, 2025

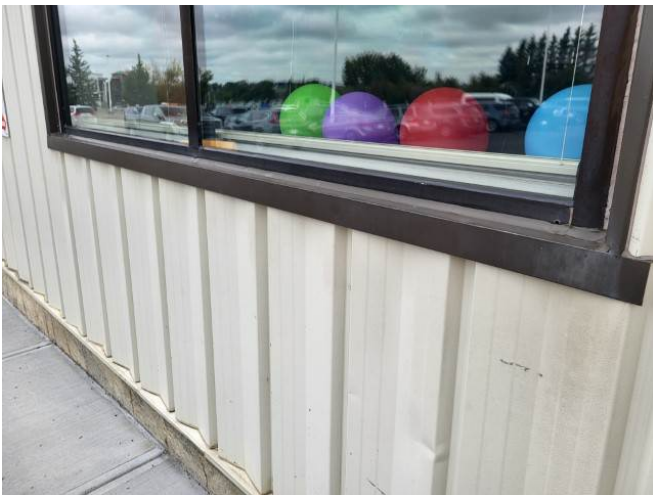
Aug 15 \_Window Sill Sealant Replaced

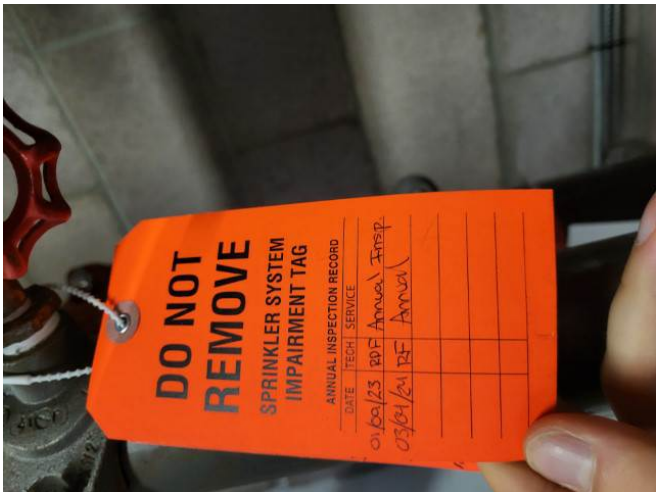
- The sprinkler system and fire extinguishers are overdue for inspection.
- The wet chemical fixed fire protection extinguishing system protecting the stainless steel kitchen hood system of the north kitchen area are overdue for inspection.

Sprinkler System - Overdue for Inspection

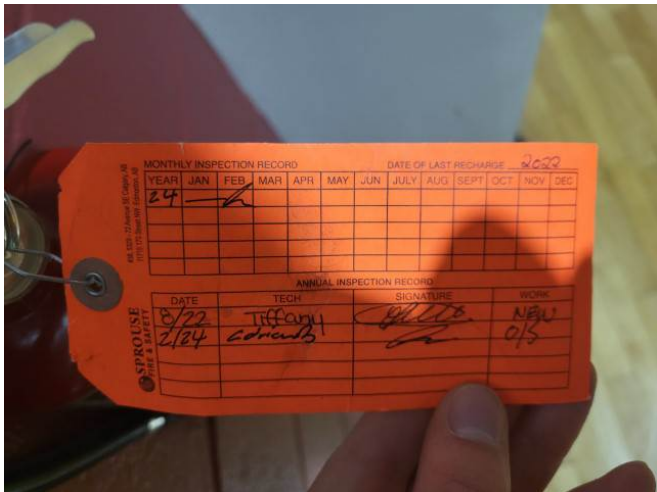
Fire Extinguishers - Overdue for Inspection

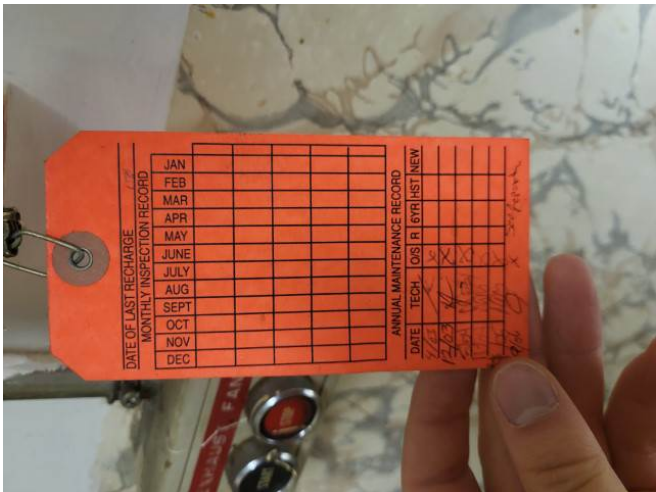
Chemical suppression System - Overdue

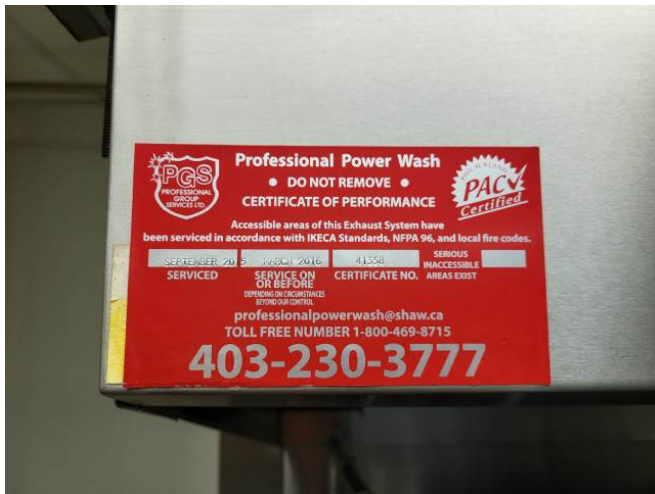
- The professional power wash for the hood are overdue and required to be updated before using the kitchen appliance.
- No portable K-Type fire extinguisher was observed close to the Cooking appliance.

Kitchen Hood Professional Power Wash - Overdue

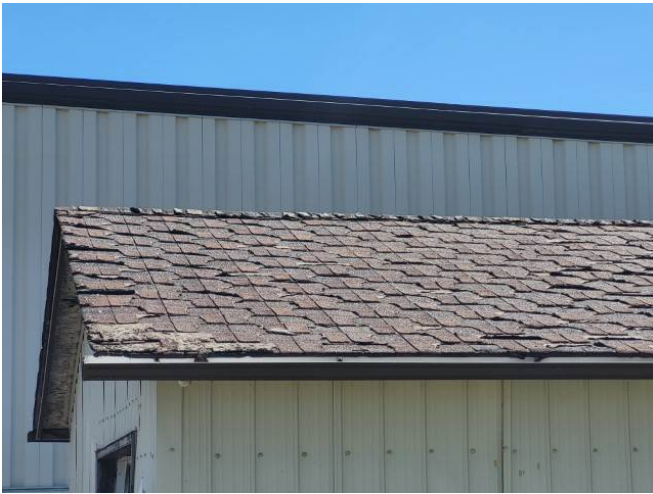
Storage Shed - Roof

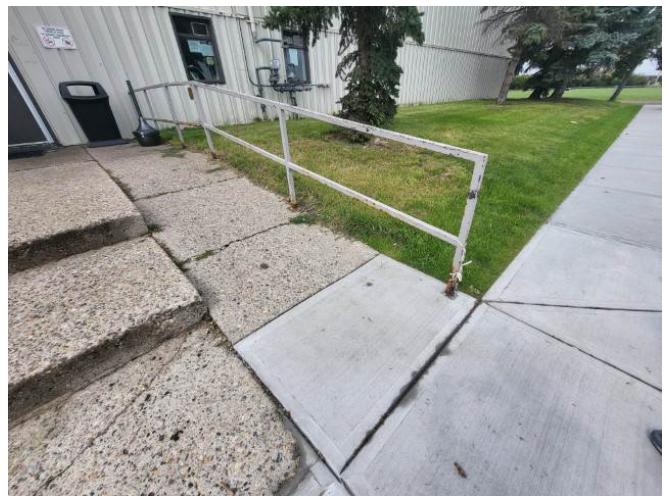
Aug 15\_Railing Secured in Concrete

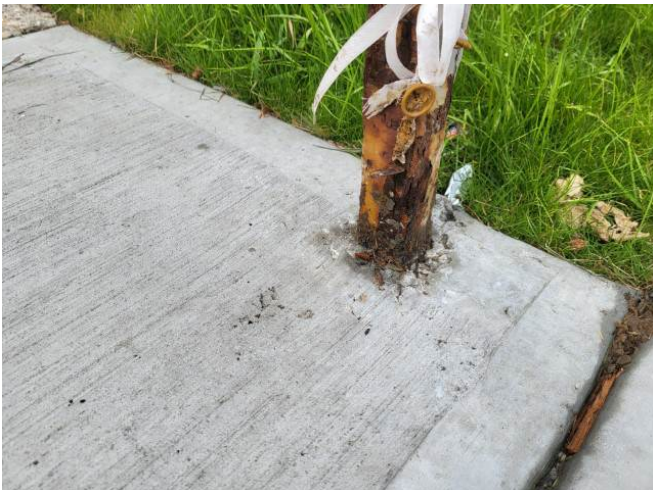
Aug 15\_ Railing Embedded in Concrete\_Corrosion Present

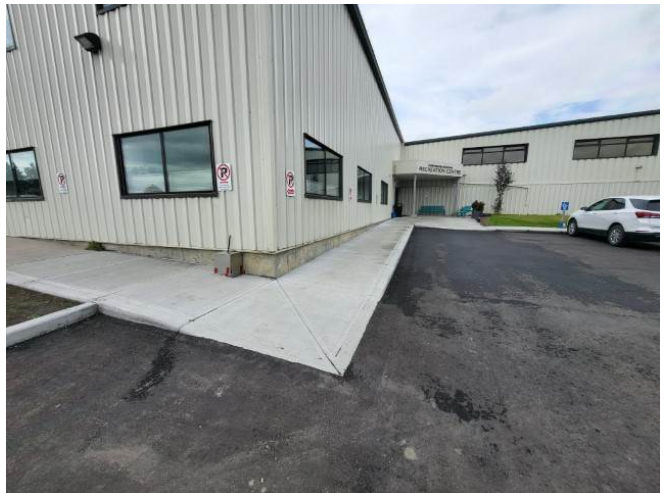
Aug 15\_ Concrete Sidewalks Replaced

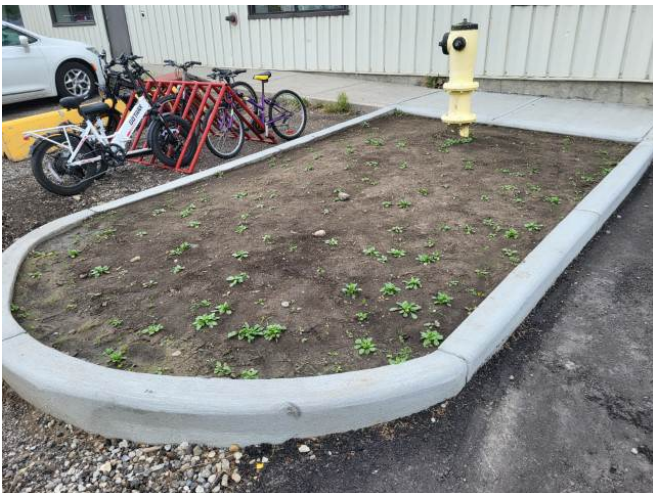
Aug 15\_ Concrete Curb Constructed Around Fire Hydrant

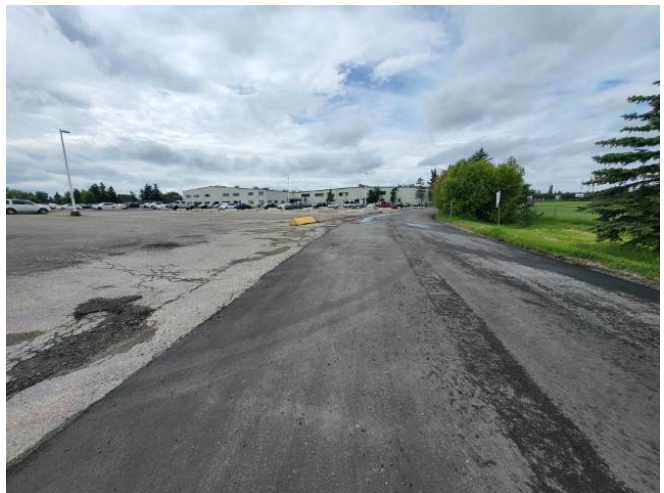
Aug 15\_ Asphalt Pavement Replaced

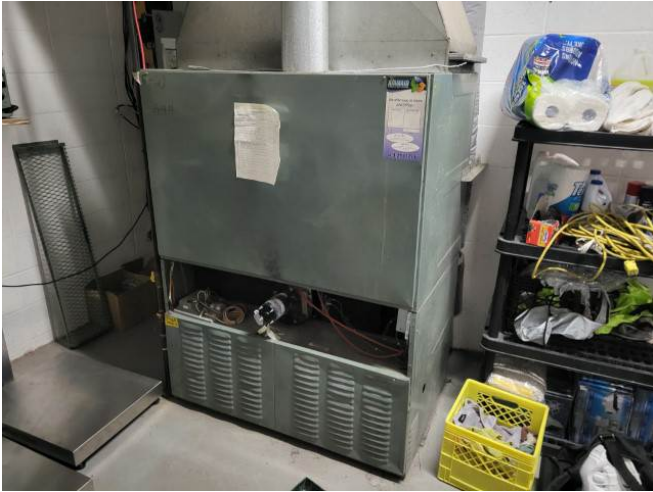
MUA - Indoor

Based on the apparent age of the units, the plan allows for phased replacement of the Engineered Air units in the mid stage of the report term.

#### 6.4.3 Replace MUA Units

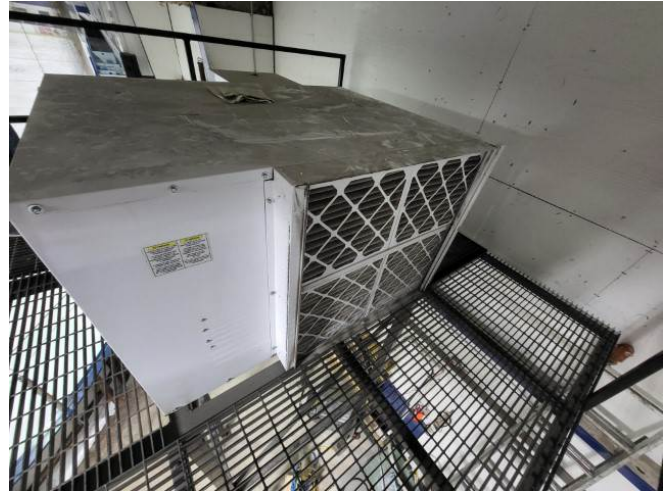
According to the Operations Manager, the Thermoplus dehumidifiers were installed in 2005 and 2012. The indoor MUA units are estimated to be 10 to 15 years old.

Dehumidifier

#### 6.4.1 Replace 2005 Dehumidifiers

#### 6.4.2 Replace 2012 Dehumidifiers

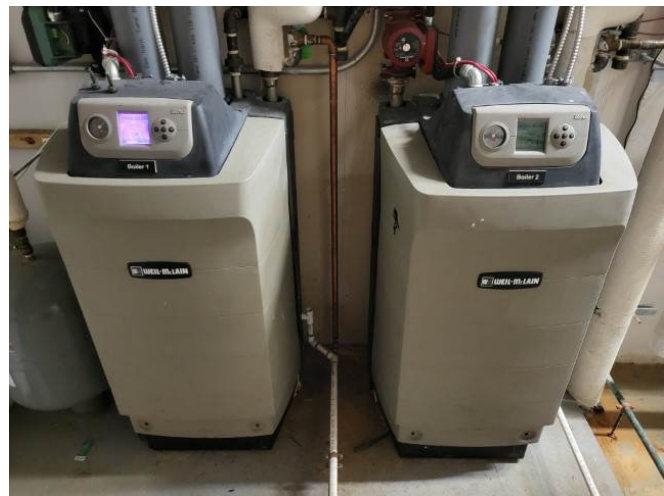
According to information available for review, the boiler and storage tanks were installed in 2014. Boilers have a typical service life of about 35 years and the storage tanks have a typical service life about 15-20 years. Based on the age and reported condition of the boilers, replacement is expected after the report term. However, replacement of the storage tanks are expected within the mid period of the report term. A budget has been included.

Domestic Water Boilers

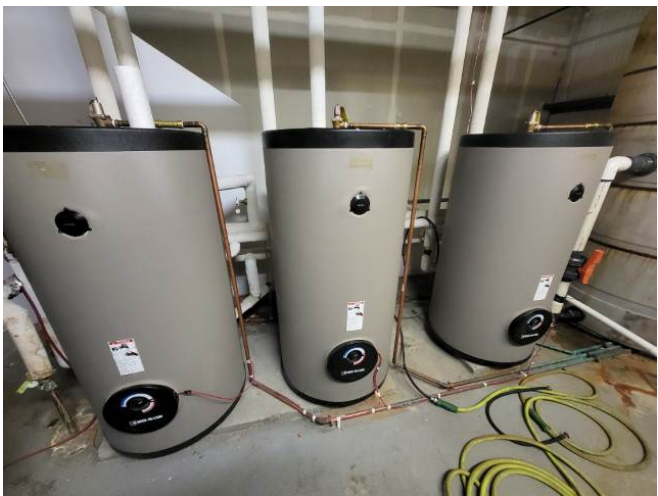
Domestic Hot Water Storage Tanks

7.1.1 Replace Water Storage Tanks

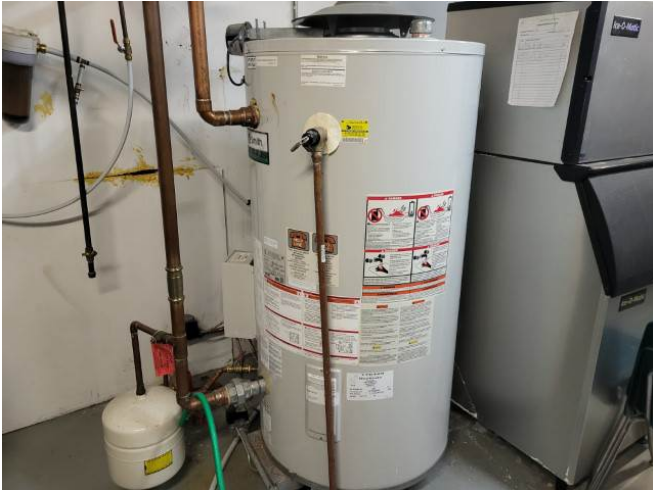
The Operations Manager reported no issues with the domestic water storage tanks. Hot water tank heaters have a typical service life of about 12-15 years. Based on age, replacement of both tanks is expected within the report term. Budgets have been provided.

Domestic Hot Water Heater Serving Blue Arena

#### 7.2.2 Replace DHW Storage Tank Heater - 2021

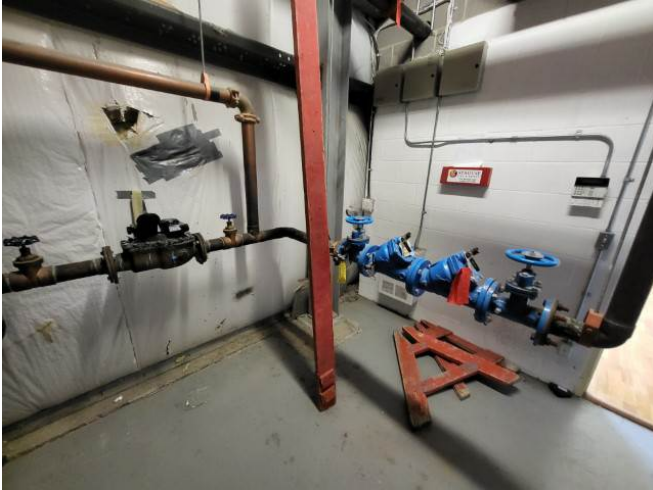
The Operations Manager reported some minor pinhole leaks, but that to date, these have been manageable via localized repairs.

The BFPs were last inspected by Sprouse in April, 2024 and are overdue for inspection. Based on a typical service life of about 20 years, replacement of the BFPs is expected within the report term. Budgets have been provided.

Water Services

#### 7.3.1 Replace Backflow Preventors

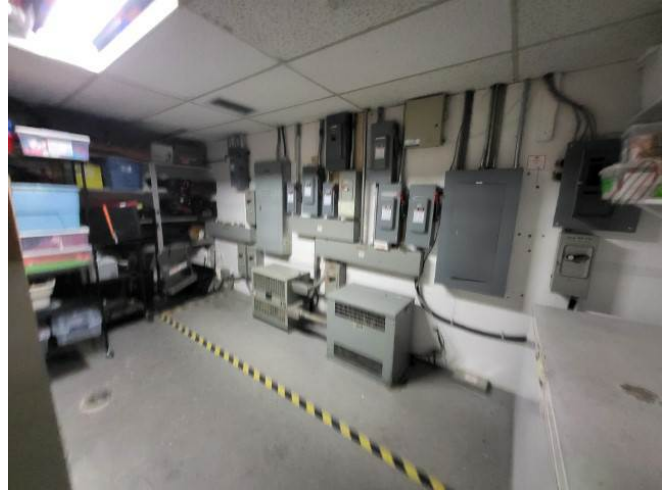
Some of the distribution panels and disconnect switches for the Blue and White Arenas were noted to be original to construction of their building section and are about 40 years of age. Based on apparent age and a typical service life of about 40-50 years, we have provided budgets to replace the original equipment within the report term.

During the site visit, it was noted that items are being stored in the vicinity of electrical equipment. Items should be kept at least one metre away. We assume these deficiencies will be addressed as part of routine maintenance.

Blue Arena Electrical Room

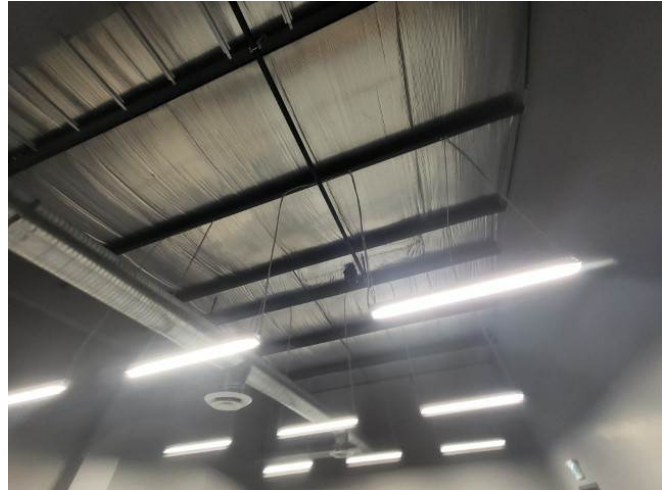
The service areas of the building are lit by strip fluorescent fixtures using T12 lamps. T12 lamps are becoming obsolete due to rapid advances in lighting technology, and are being replaced with more efficient systems. In some locations, T12 lamps and ballasts are becoming difficult to obtain. We suggest planning to upgrade or replace these lights with more energy efficient and readily available systems (e.g. T8, T5, LED). Given the limited amount of lighting, we expect the fixtures will be retrofitted or replaced as they burn out, as part of ongoing maintenance.

Strip Lighting

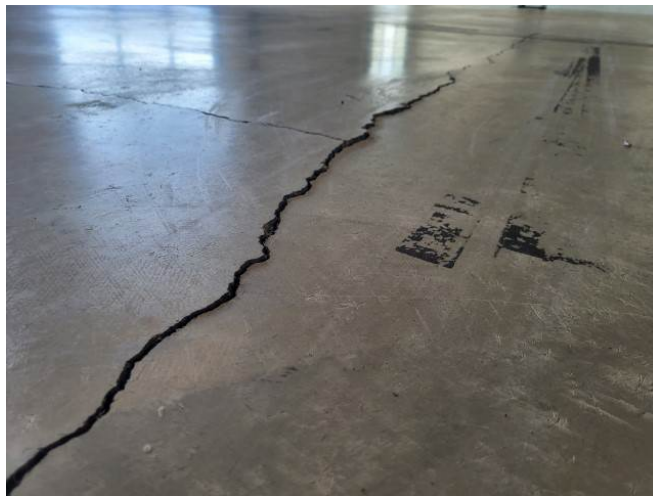
Photo #5: Cracking and Displacement in the 2nd Floor Slab of Undeveloped Area

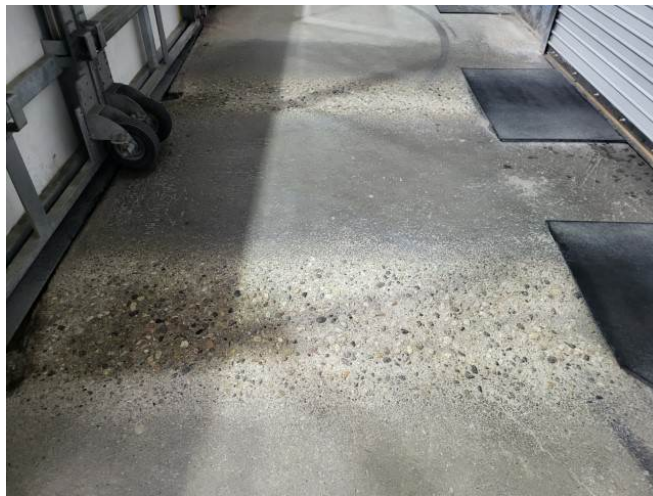
Photo #8: Deteriorated Slab on Grade in Zamboni Garage (Small)

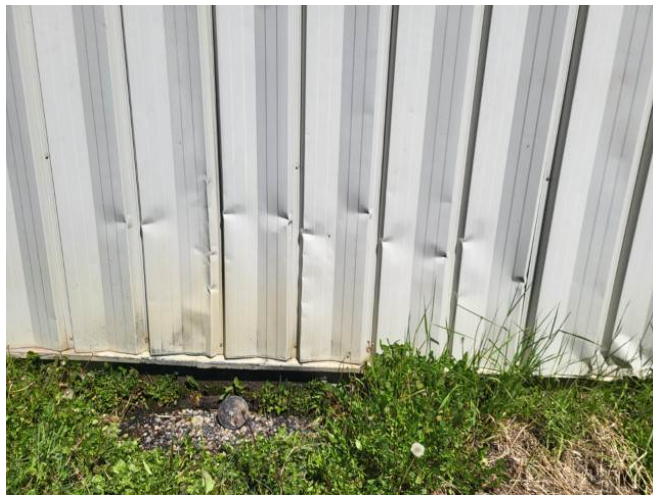
Photo #14: Dented Cladding - South Elevation

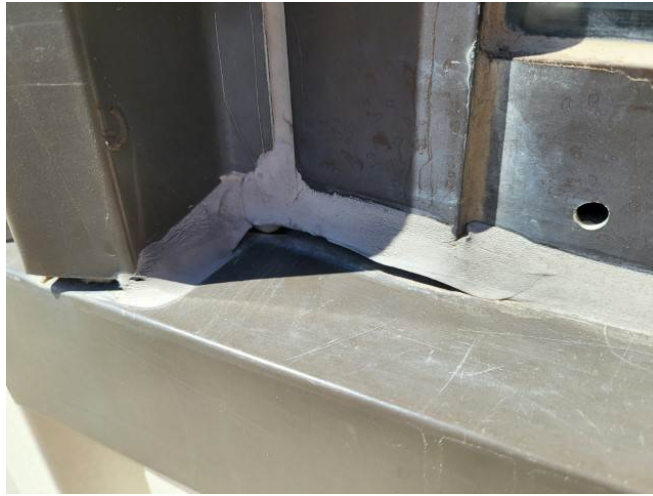
Photo #19: Debonded Perimeter Window Sealant

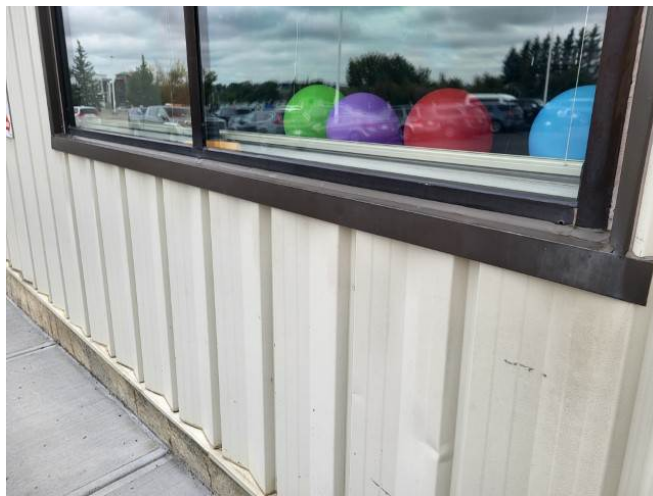
Photo #20: Aug 15\_ Window Sill Sealant Replaced

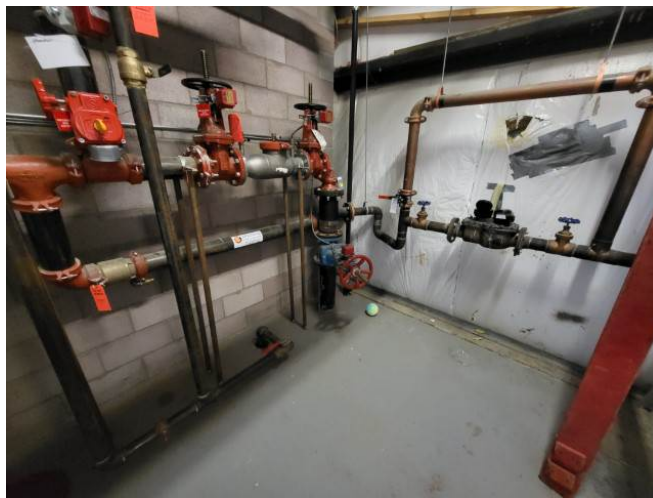
Photo #31: Sprinkler Risers

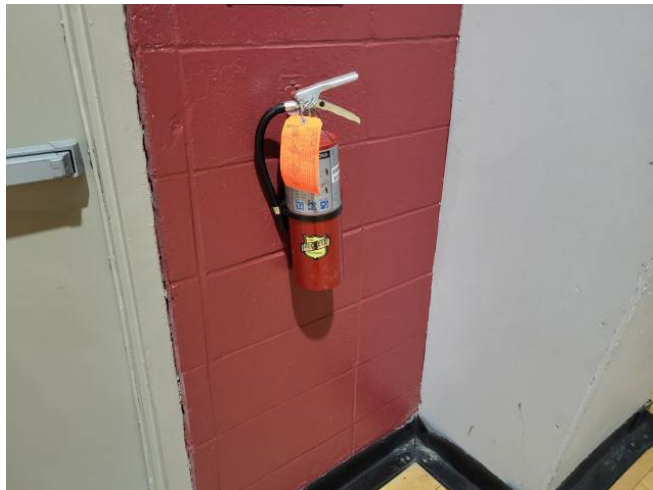
Photo #32: Typical Fire Extinguisher

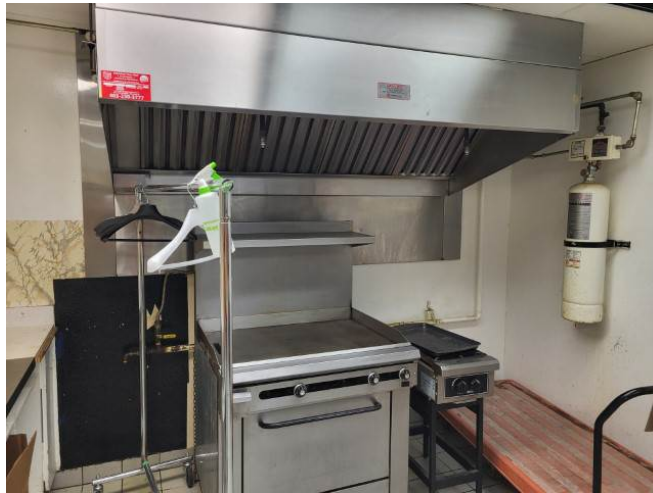
Photo #33: Kithen Hood

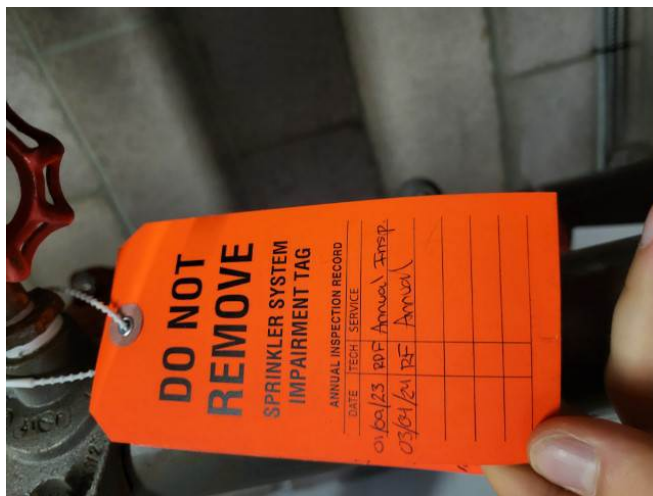
Photo #34: Sprinkler System - Overdue for Inspection

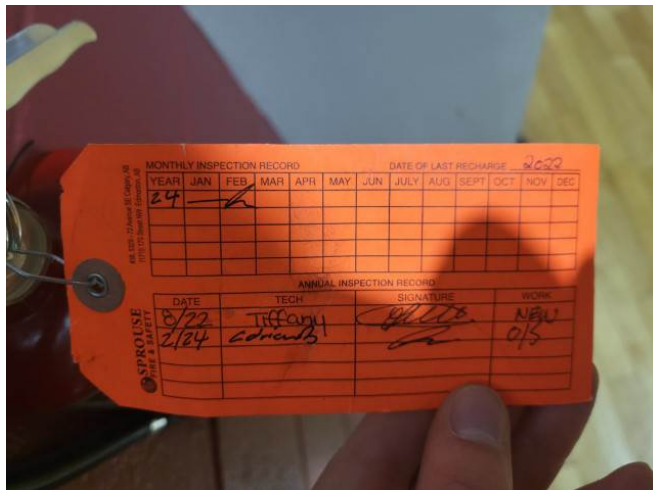
Photo #35: Fire Extinguishers - Overdue for Inspection

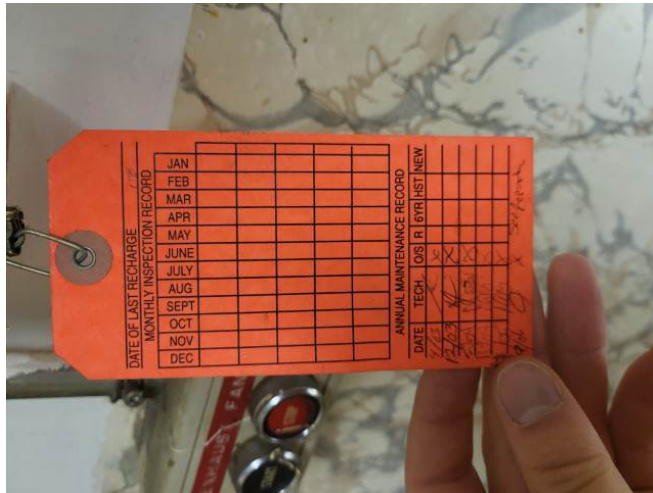
Photo #36: Chemical suppression System - Overdue

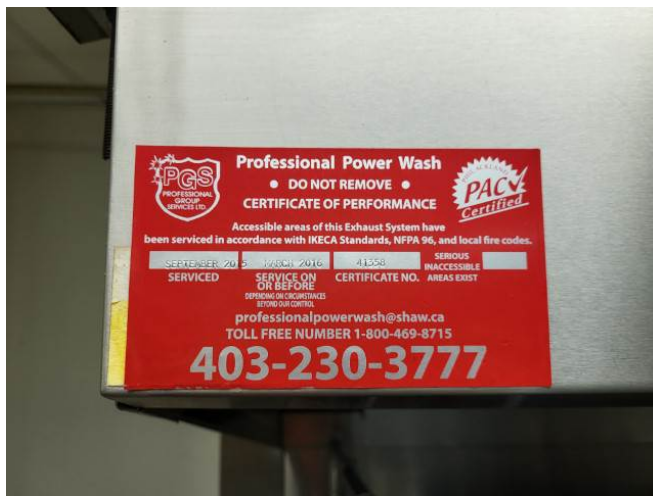
Photo #37: Kitchen Hood Professional Power Wash - Overdue

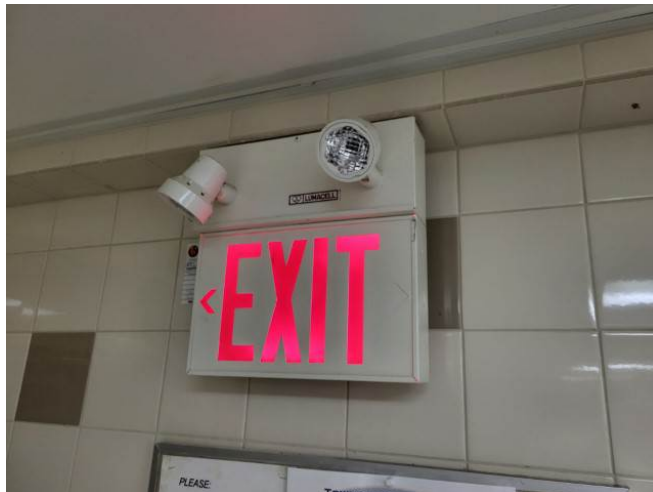
Photo #38: Typical Emergency Lighting and Exit Sign

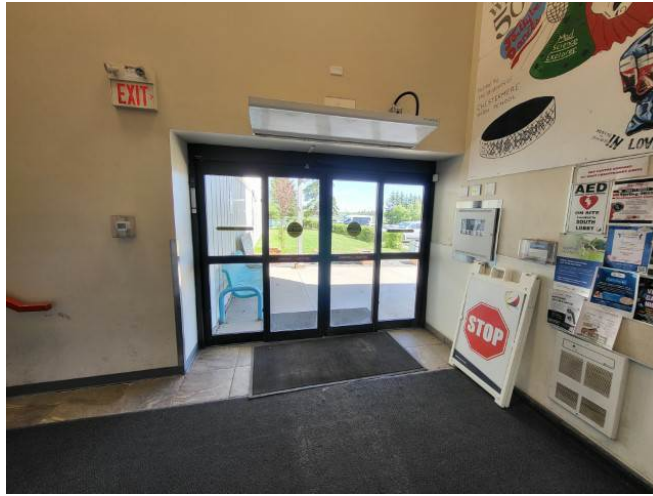
Photo #39: Main Entrance Lobby

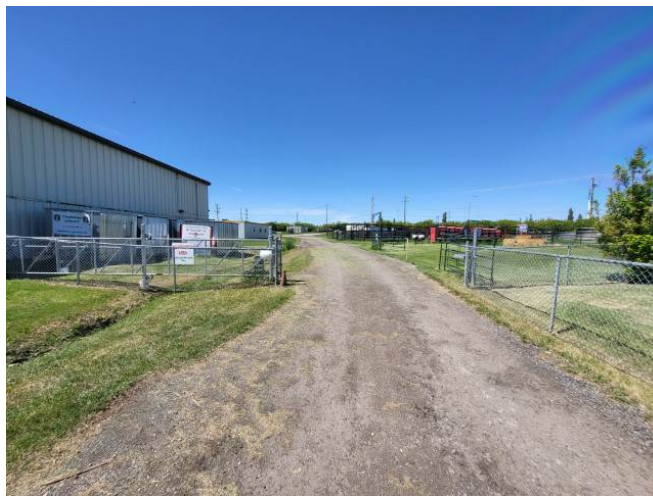
Photo #43: Chain Link Fencing and Gates

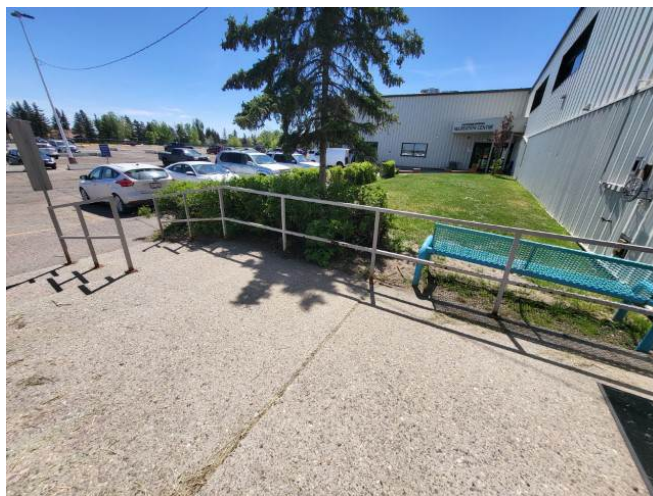
Photo #46: Metal Railing - Main Entrance

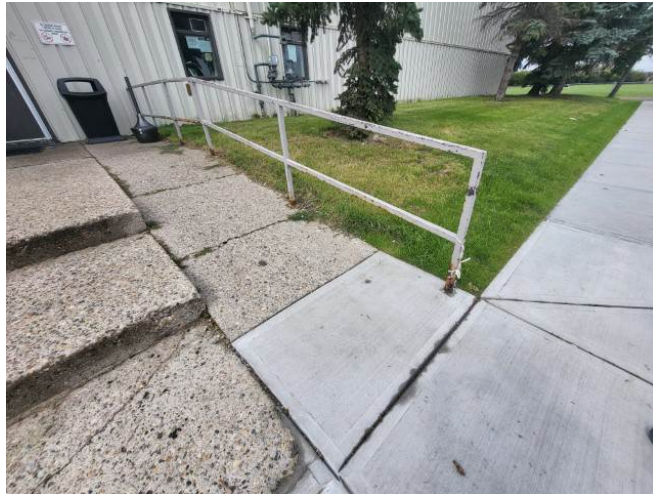
Photo #48: Aug 15\_ Railing Secured in Concrete

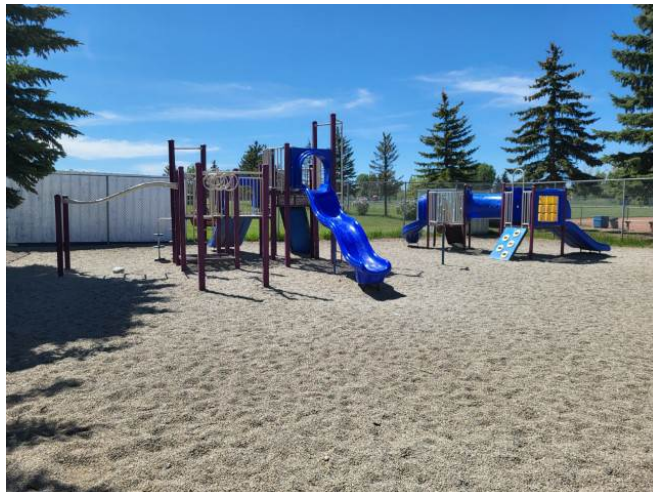
Photo #50: Play Ground

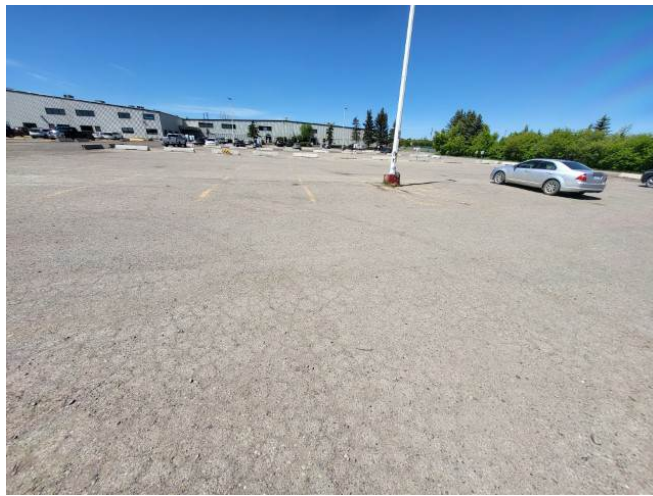
Photo #58: Parking Lot

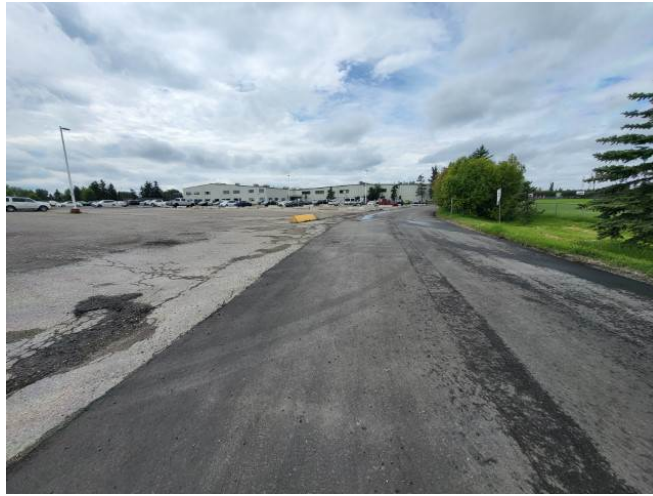
Photo #60: Aug 15\_Aspphalt Pavement Replaced

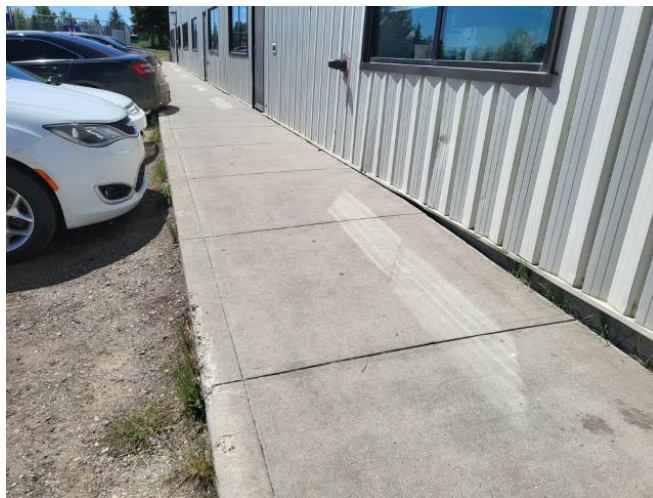
Photo #61: Typical Concrete Walkway

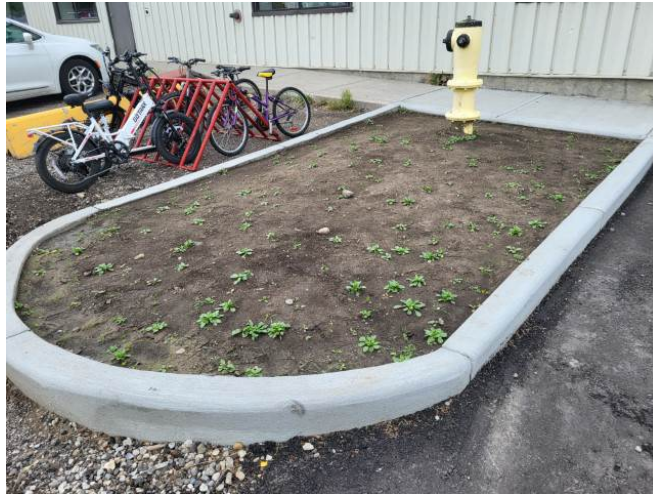
Photo #63: Aug 15\_Concrete Curb Constructed Around Fire Hydrant

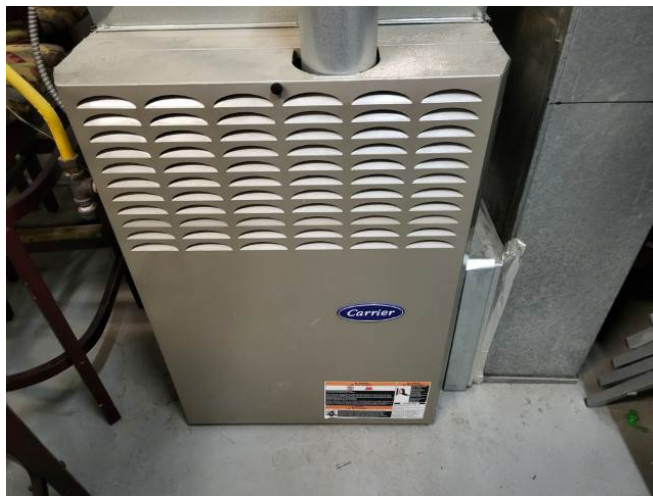
Photo #64: Typical Furnace

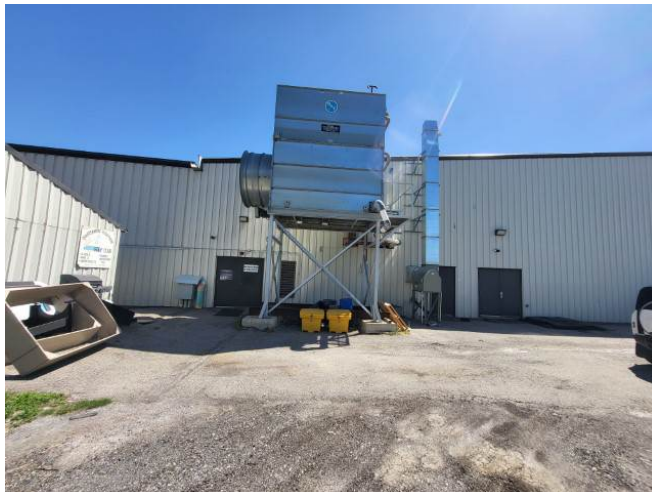
Photo #83: Red Arena Cooling Tower
